## Technical Information (TI) from Factory to Distributors

| <b><u>MODEL and YEAR</u></b><br>EC 250 / 300 2018 | <b><u>SUBJECT:</u></b><br>DIFFICULT ELECTRIC START | <b><u>ISSUE DATE:</u></b><br>03/11/2017 | <b><u>TI Nº:</u></b><br>GGT – 03<br>(Rev 08/03/2018) |

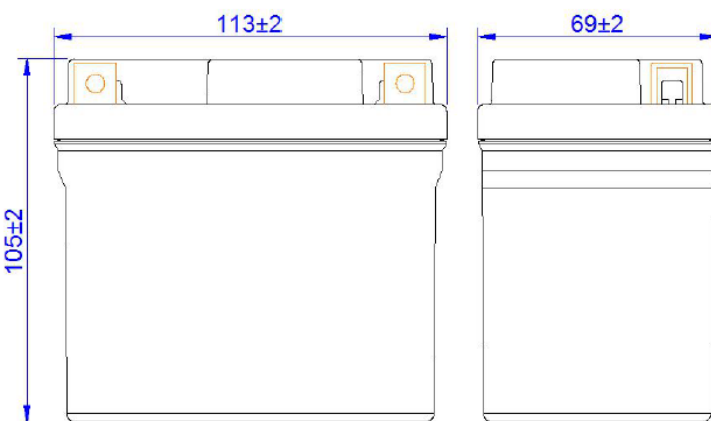
| <b><u>Symptom:</u></b> | <p>In some units there is a problem with the electric start of model <b>EC 250-300 y 250-300 GP 2018</b>.</p> <p>It has been detected that, with the battery charged, the electric start does not function correctly with the electric motor, on the contrary, using the start pedal, boots correctly.</p> |

| <b><u>Countermeasure:</u></b> | <p>1/ This action cancels the replacement of the Rotors with CDI of our original circular (November 3<sup>rd</sup> Nov 2017). No more kits will be delivered. Those who have replaced it do not harm this action.</p> <p>2 / Ensure that the CDIs (EE51100CT-CRB-1) have been reprogrammed to (EE51100CT-CSK-1) according to the circular GGT-04 of March 1, 2018.</p> <p>Therefore:<br/>To improve the electric starting system, we recommend installing:</p> <ul style="list-style-type: none"> <li>• 1 / Larger capacity battery, with a value equivalent to "<b>minimum 240 CCA</b>":<br/>SKYRICH HJTZ7S-FPZ 48 WH <b>CCA 240</b><br/>(EE40000GG-CSK-1 BATTERY LITIUM 4.0 Ah, HJTZ7S-FPZ ).</li> <li>• 2 / Battery cables.<br/>Ground cable: EE10000103013 (available in Dpt Spare Parts)<br/>Positive cable: EFS400152510 (available in Dpt Spare Parts)</li> </ul> <div style="text-align: center;"> </div> <p>We remain at your disposal.</p> <p>Dani Ortiz (<a href="mailto:attclientes@gasgas.com">attclientes@gasgas.com</a> )<br/>Aleix Julia (<a href="mailto:ajulia@gasgas.com">ajulia@gasgas.com</a>)</p> |
