### Información Técnica (TI) de Fábrica a Distribuidores

| <b><u>MODEL and YEAR</u></b><br>EC 250 / 300 2018 | <b><u>SUBJECT:</u></b><br>CDI: Wrong mapping | <b><u>FECHA</u></b><br><b><u>EMISION:</u></b><br>March 9th, 2018 | <b><u>TI Nº:</u></b><br>GGT – 04 |

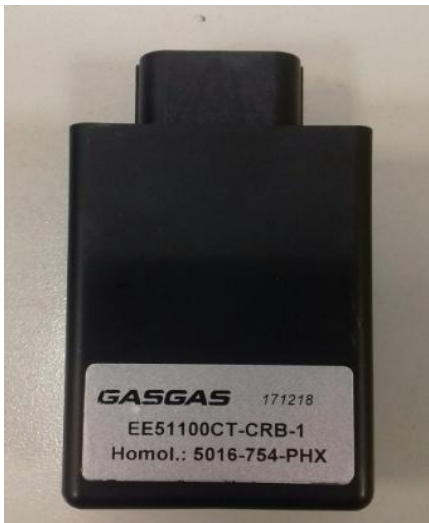
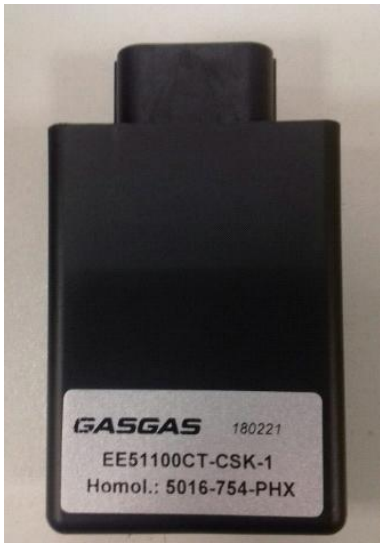
| <b><u>Symptom:</u></b> | Too lean combustión mixture. This might provoke engine broken (Piston-cylinder)<br>The CDI (EE51100CT-CRB-1) have a wrong mapping installed. |
| <b><u>Picture:</u></b> | <div style="display: flex; align-items: center; justify-content: center;"> <div style="text-align: center;"> <p><b>EE51100CT-CRB-1</b></p> </div> <div style="font-size: 2em; margin: 0 20px;">➔</div> <div style="text-align: center;"> <p><b>EE51100CT-CSK-1</b></p> </div> </div> |

| <b><u>Countermeasure:</u></b><br><br><b><u>Repair Procedure:</u></b><br><br><b><u>Affected lot:</u></b> | <p>According the ATTACHED LIST OF AFFECTED VIN's. is need to reprograma ll of them urgently.</p> <p>You have been received a CABLE the is need need for the upgrade.</p> <p>Follow the ATTACHED EXCEL FILE for the upgrade procedure.</p> |

| <b><u>Countermeasure parts:</u></b> | Please submit the warranty application to DEIWEB with the part number and its VIN.<br>EE5100CT-CSK-1 | | |
