## Technical Information (TI) from Fabric to Dealers.

| <b>MODEL and YEAR:</b><br>EC 250 / 300 2018 | <b>SUBJECT:</b><br>FRONT AXLE | <b>DATE RELEASE:</b><br>03/05/2018 | <b>TI Nº:</b><br>GGT - 06 |

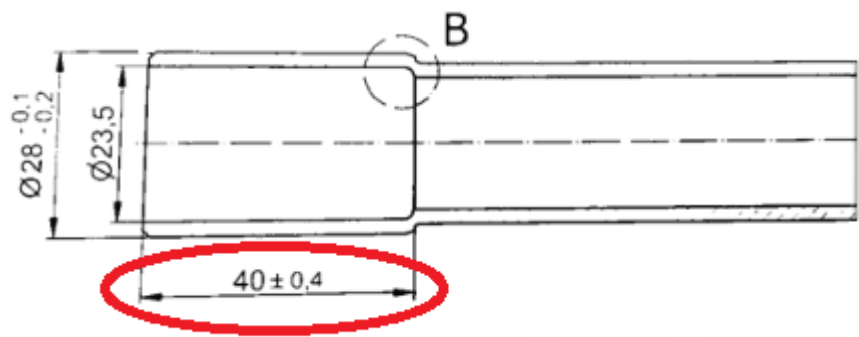
| <b>Repair procedure:</b> | <p>To know if the axle is correct, the method of verification is the following:<br/>The dealer must check the internal depth measurement on the front axle. If it is incorrect, it must be replaced by a correct axle. Some of major markets are receiving some axles for your initial demand. If you need more quantities, you should ask our Spare Parts Department (see below).<br/>The verification method is as follows:</p> <ul style="list-style-type: none"> <li>• <u>Correct</u> measure: <math>40 \pm 0.4</math> m/m</li> <li>• <u>NOT correct</u> measure: <math>47 \pm 0.4</math> m/m</li> </ul> <p>TECHNICAL ASPECTS:</p> |

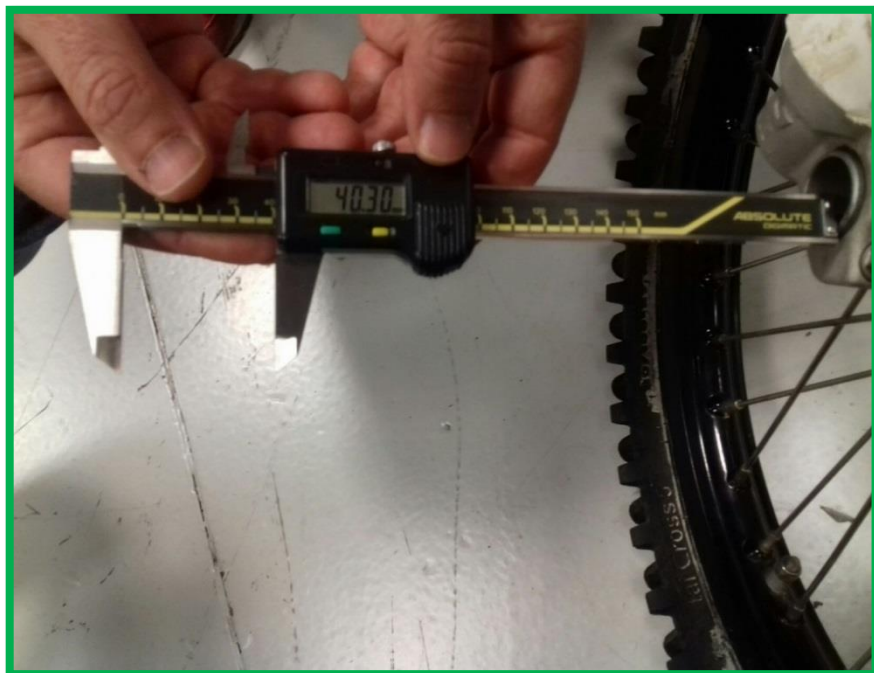
MEASURE OK → **AXLE OK**

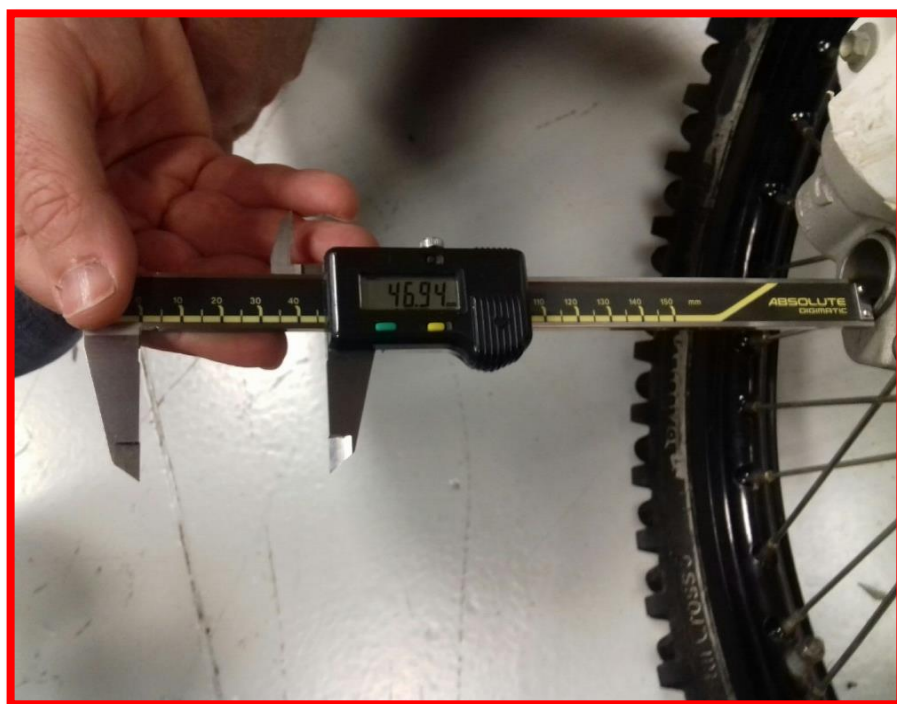
MEASURE **NO OK!**
