Technical Information (TI) from Fabric to Dealers.

MODEL and YEAR:	SUBJECT:	DATE RELEASE:	<u>TI Nº:</u>
EC/XC 250 / 300 2019	CRANK SHAFT PINION LOCKING NUT	25/01/2019	GGT - 08

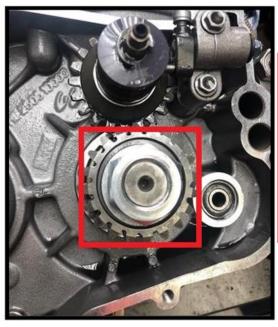
iii NUT NON OK !!!

In very extreme cases, it has been detected that the lock nut of the crankshaft pinion has excessive clearance in the thread. It can become loosed causing damage to the engine in the models GASGAS EC/XC 250/300 2019.

<u>-Defective nuts:</u> All metalized nuts and "non cutted-edges" nuts must be replaced by prevention, as a matter of urgency.

In case of finding a defective nut, replace with a correct one provided by the spare parts department. **Tightening torque of 80N · m. Apply Loctite blue 648.**

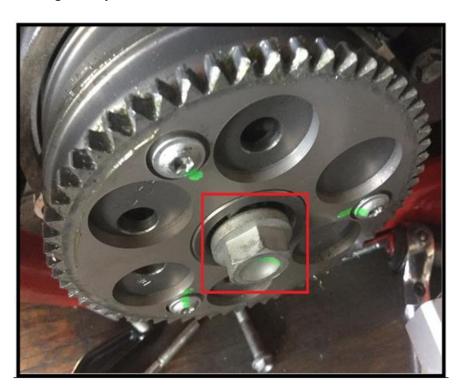
B / If the defective nut encounters a very weak tightening torque, then ensure that the torque of the magnetic flywheel screw is 50N · m value.
