### Información Técnica (TI) de Fábrica a Distribuidores

| <b><u>MODEL and YEAR</u></b><br>EC 250 / 300 2018 | <b><u>SUBJECT:</u></b><br>CDI: Wrong mapping | <b><u>FECHA</u></b><br><b><u>EMISION:</u></b><br>March 9th, 2018 | <b><u>TI Nº:</u></b><br>GGT – 04 |

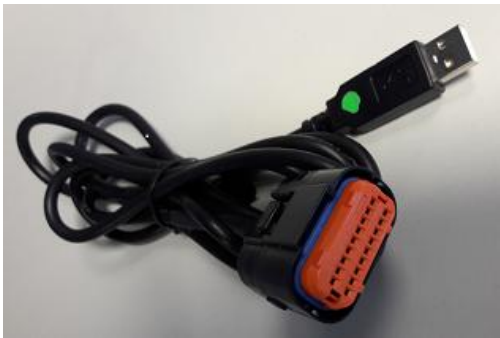
| <b><u>Symptom:</u></b> | Too lean combustión mixture. This might provoke engine broken (Piston-cylinder)<br>The CDI (EE51100CT-CRB-1) have a wrong mapping installed. |

| <b><u>Countermeasure:</u></b><br><br><b><u>Repair Procedure:</u></b><br><br><b><u>Affected lot:</u></b> | <p>According the ATTACHED LIST OF AFFECTED VIN's. is need to reprograma ll of them urgently.</p> <p>You have been received a CABLE the is need need for the upgrade.</p> <p>Follow the ATTACHED EXCEL FILE for the upgrade procedure.</p> |
